③ ANATOMY OF A SINKING

The postmortem of a perhaps preventable offshore-racing mishap provides a series of lessons learned that are applicable to any bluewater boat. BY STEVE D'ANTONIO

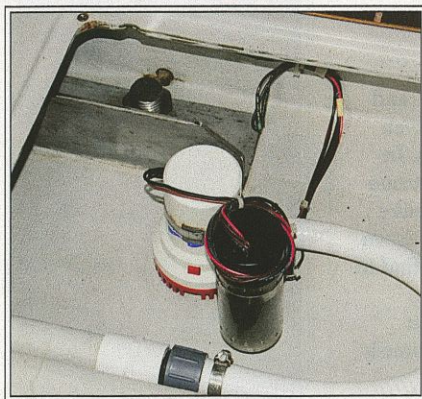
Bilge-pump capacity is like fire extinguishers; you never can have too much. There should be a submersible pump in each bilge compartment, and overall capacity should be no less than 100 gallons per hour per overall foot of vessel length (i.e., a 45-foot vessel should have at least 4,500 gph worth of pump capacity). Pumps, float switches and high-water alarms can be properly tested by only one means: filling bilges with water and observing the results. This is because pumps that run do not necessarily pump water.

Bilge pumps should serve every bilge compartment, ideally providing no less than 100 gallons per hour of dewatering capability for every foot of hull (left). A fothering patch can be used to stem the water from a hull breach, and are especially useful in cases where the leak cannot be quickly or easily accessed from inside the boat (middle). A clear, easy-to-read “map” of all hull penetrations can be valuable in a flooding scenario, especially when new crew are aboard (right).

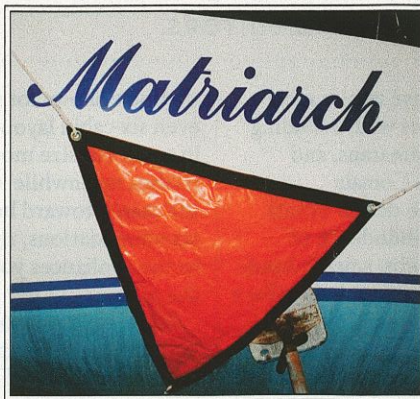
If a vessel begins to take on water after striking an object, it stands to reason that the damage is forward—if not in the hull itself, then perhaps in a transducer. Regardless, if the ingress cannot be quickly identified, a fothering patch can buy time while the problem is dealt with. These are inexpensive and easy to use provided conditions are moderately calm; in this case, they were.

Test your high-water alarm and pumps regularly, and make certain your damage-control kit includes a fothering patch.
