Mitch Witt Marine Surveyor

Survey of:

50' Ta Yang Sloop 1981

Pleasure Vessel Survey

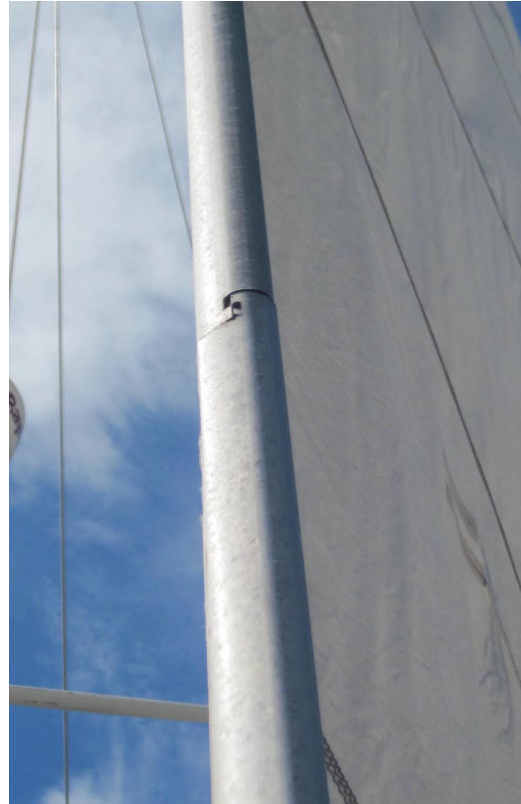
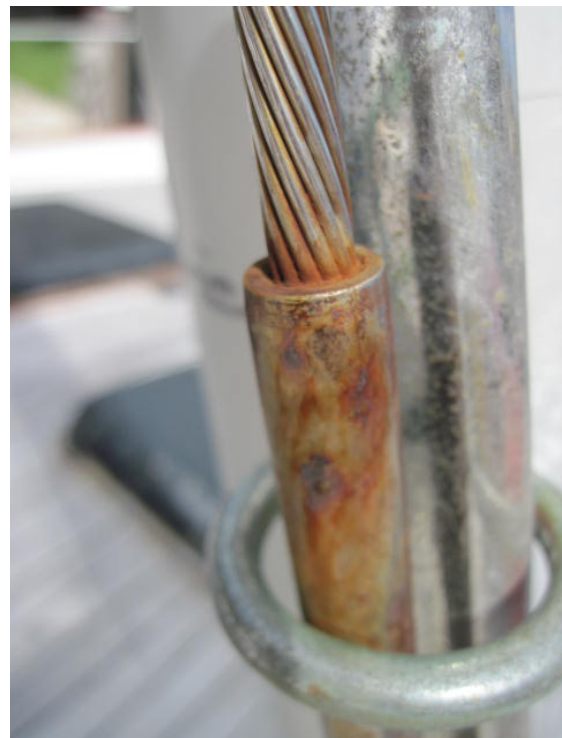
Stays Uppers and aft lower are 10mm wire. Upper and forward lower are 8mm.
Lower terminations all Norseman fittings in average condition except for forward lowers which are swages that are rusting. [See Photo](#)

Forward lowers - heavy corrosion.

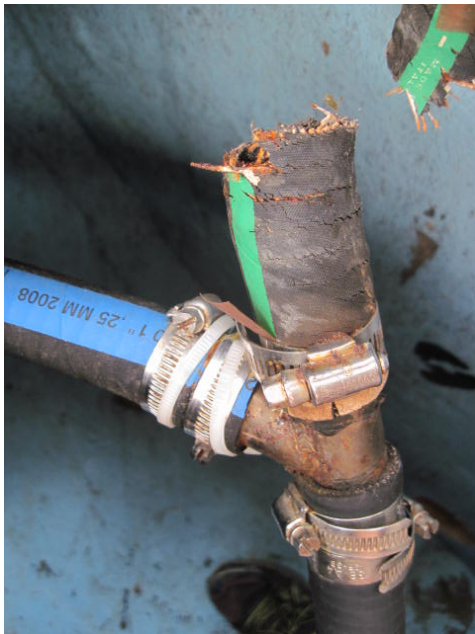
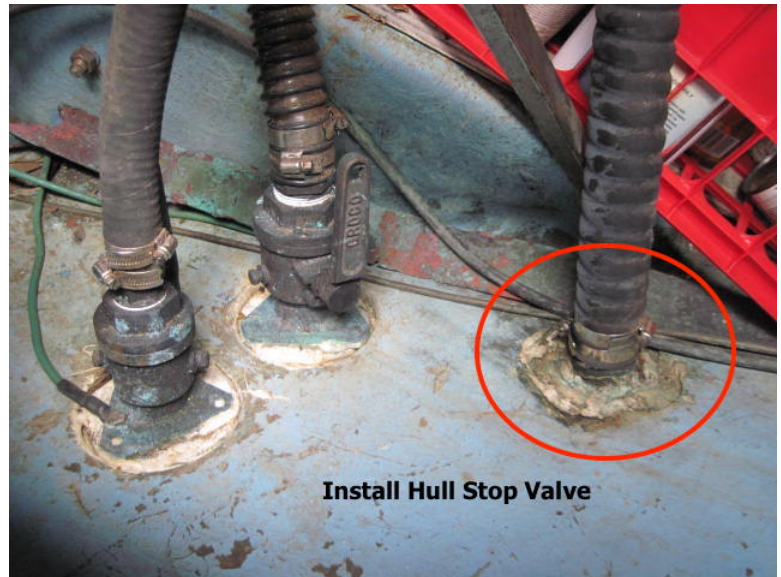
Locate and replace old & degraded hoses and

clamps.

- 7 Replace degraded hoses and rusted clamps throughout (Engine, Head, Generator, Fuel Systems, etc.) and address other issues in Plumbing section.
- 8 Replace cracked glass in fixed port. All fixed ports in need of cleaning or replacement.

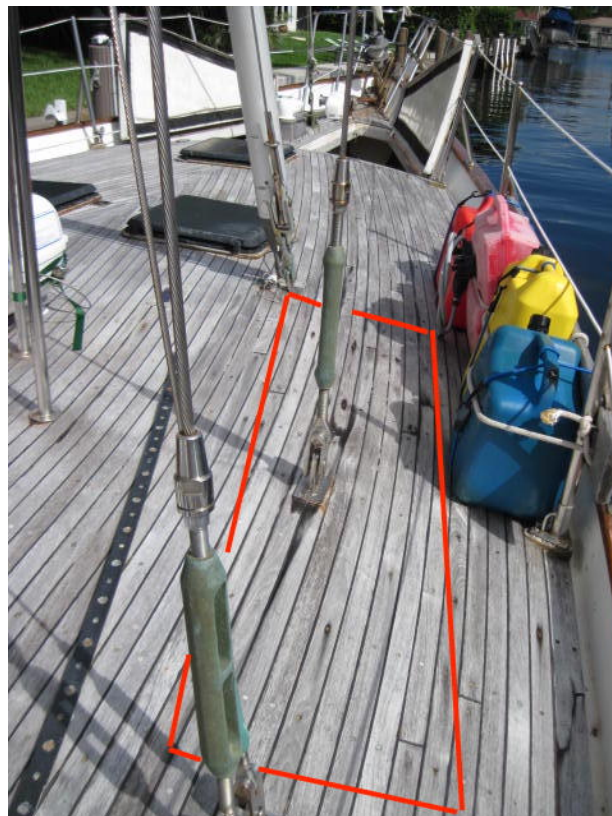
Sounding of Deck:	Decks and cabin top are TEAK which is showing their age. Bungs missing, raised grain and some fittings and fasteners standing proud. Areas starboard side of mast between chain plates are soft. Extent of problem unknown. see photo pg 17. Repair of all soft spots and delamination is a priority in order to restore vessel's seaworthiness and value. <i>Anticipate more areas than currently identified.</i>
Anti Skid Decks	Perhaps 1-3 years of functional life remaining for non skid function of teak deck before planks or sections begin to come loose.
Handholds	Teak hand rail runs along cabin top P&S. Generally in good condition with fasteners intact. Additionally, three legged stainless steel hand rail stanchions are rigidly installed port and starboard of mast. Of 1.125" tubing, clean, all fasteners intact.
Railings & Lifelines	Stanchions and Stern rails are 1.125" tubular stainless steel, 7 stanchions each side w/ gates. Stanchion bases are on deck with a brace mounted on top of coaming. PVC coated lifelines are nearing end of life. Recommend replacing, lifelines with non coated material prior to navigation.

Soft Deck Area Due To Water Intrusion At Chain Plates.

- 4 Install 30 amp *double pole* marine grade main breaker at main panel.
- 5 Repair soft areas on deck. See page 6.
- 6 Have mast and rigging inspected by qualified rigger prior to navigation. Seize all turnbuckles. Clean mast base & step. See photo page 18.

- 9 Teak decking in need of repair, nearing end of life. Complete replacement will restore value. Some areas are soft indicating water intrusion and damage to coring requiring repairs.

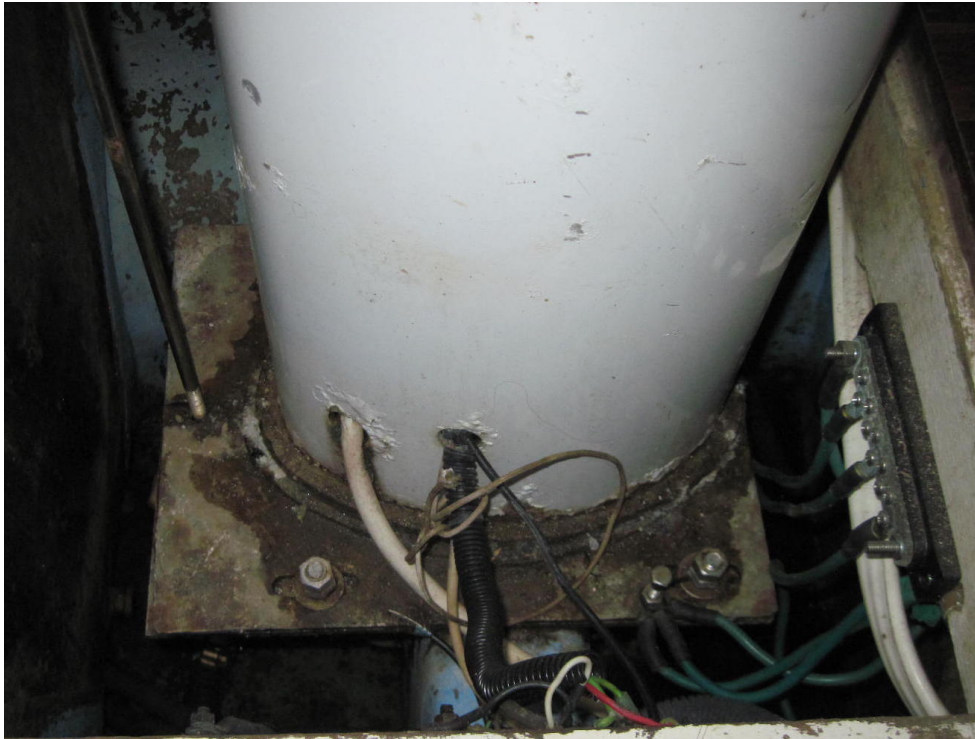
Step is a stainless steel plate bolted to a fiberglass bridge laminated between curved hull forms in the bilge. Step & mast base in need of cleaning. Keep clean and inspect regularly.
[See Photo Page 18](#)

Mast Step (*Grounds / Bonding terminal block at right*)

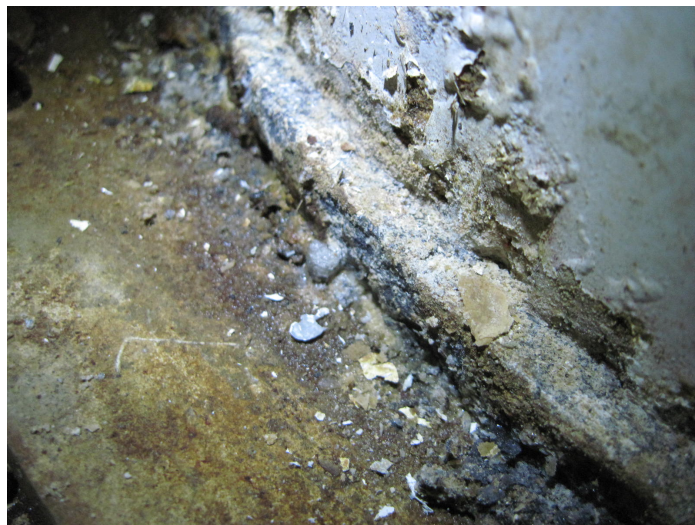
Bottom of mast & mast step in need of cleaning & repainting at the earliest opportunity.
