Catamaran Survey Report

Mitch Witt Marine Surveyor

44' Leopard Catamaran 2014

Survey Objective : Condition & Value pending purchase.

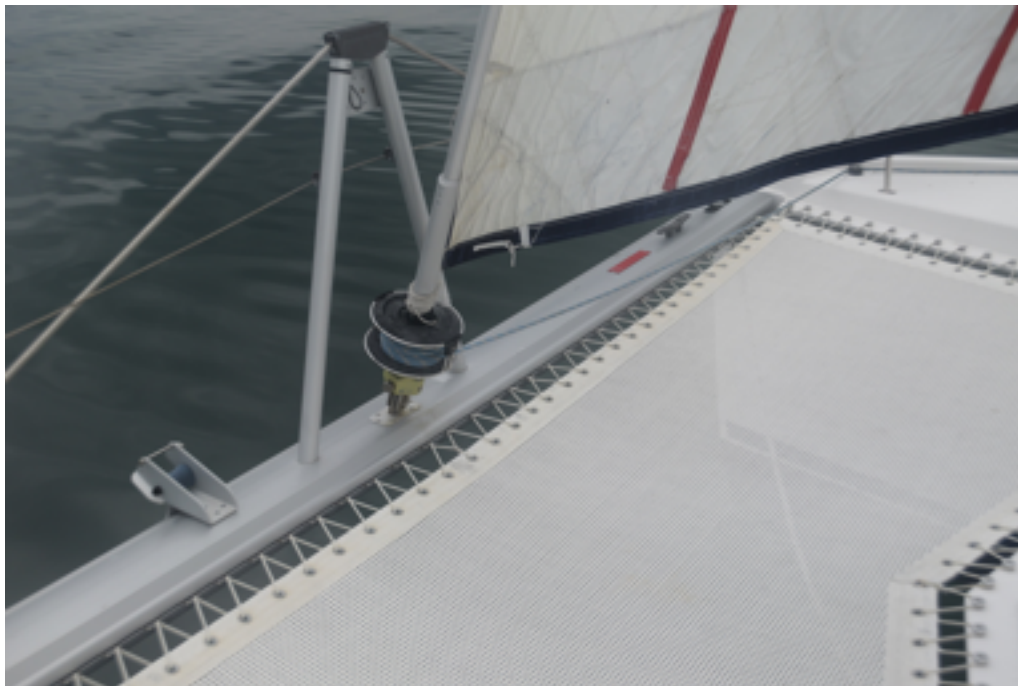
Trampoline bed in average condition.
Grommets and lacing intact, in average condition.

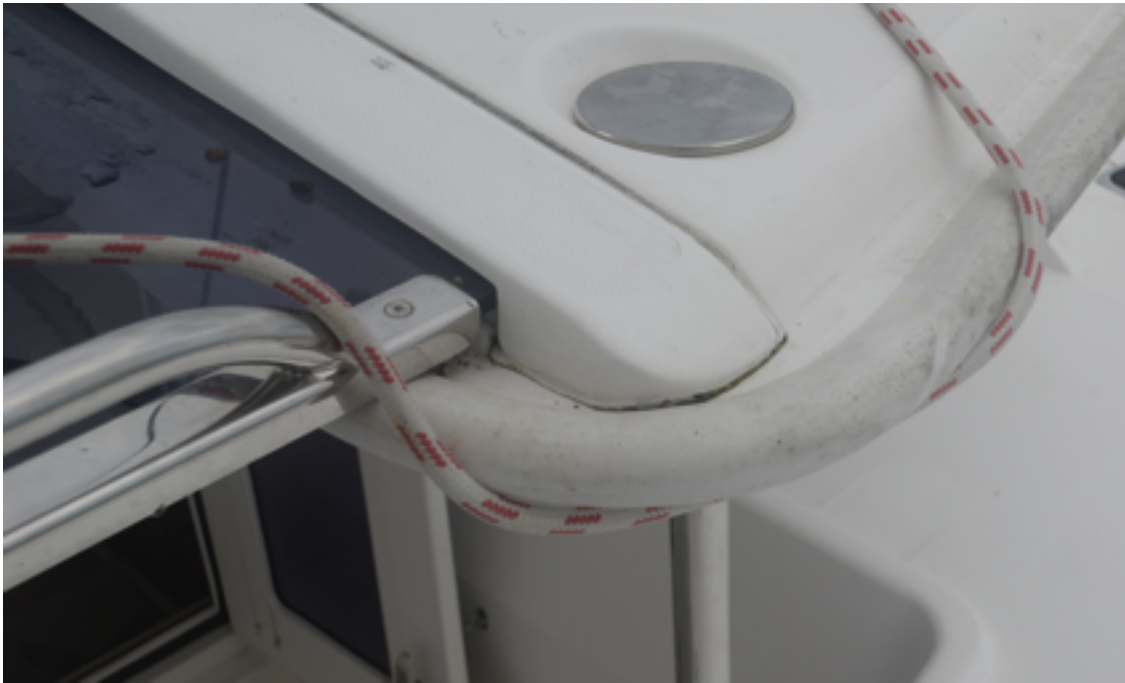
Genoa

Sheet Caught At Forward Companionway Slider.
Keep Slider Full Closed When Sailing

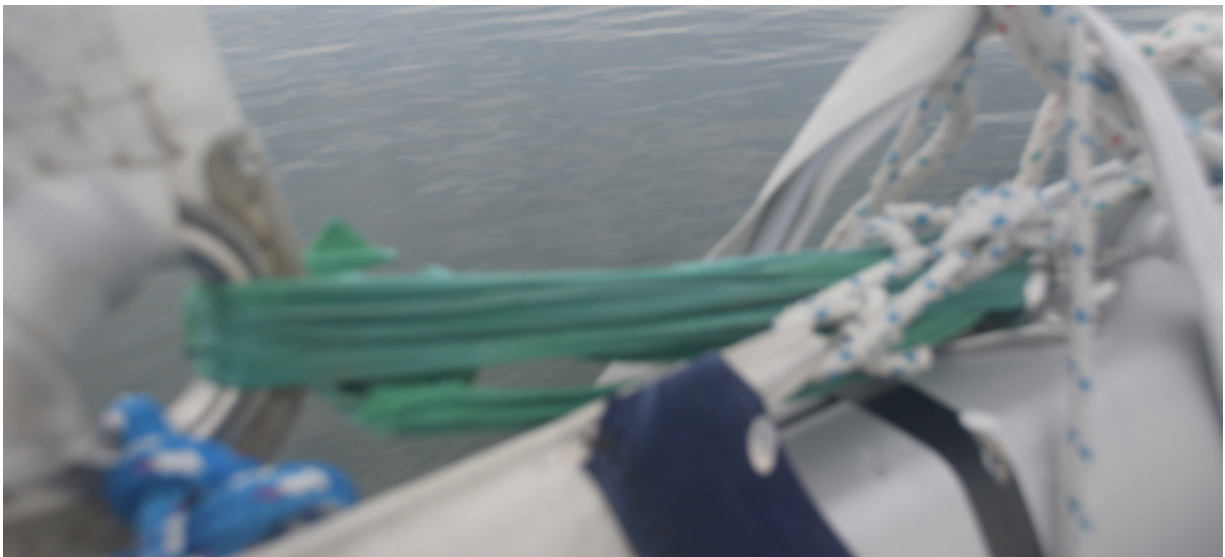
Main Sail Tack Lashed To Boom In Lieu of Outhaul

- 8 Fully Inspect boom and re-rig as necessary. Make the outhaul functional.
- 9 Provide a stern lifeline. See Railings and Lifelines, page 6.
10. Insure all below water line hoses and engine hoses ends have two clamps.

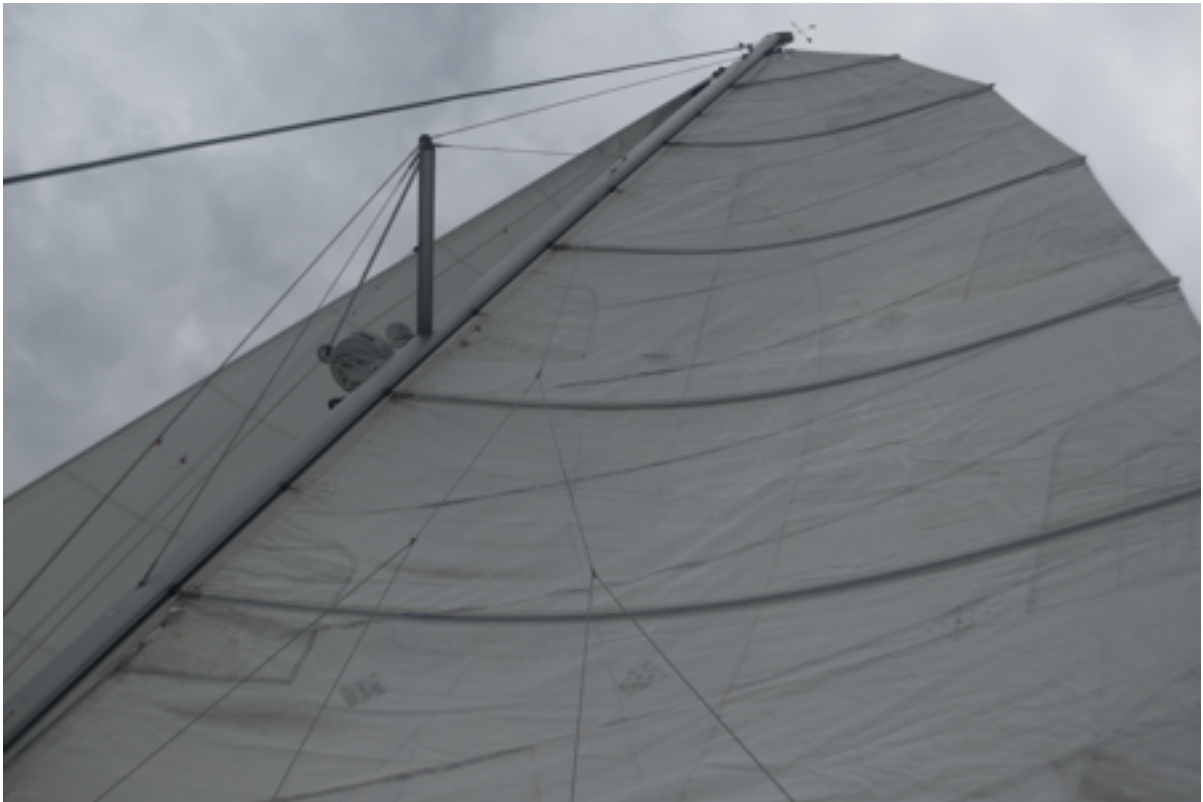
SAIL PACK Blue Sunbrella Sail pack (lined) installed on the boom providing a full length zip enclosure intended to protect the main sail from damage by ultraviolet (UV) rays. Interior shows mold. Some portions of zippers in need of restitching, overall in average condition. [Recommend removal, cleaning, repairs as needed.](#)

- 5 Inspect and recertify life raft by factory authorized service center.
- 6 Recertify and reregister EPIRB. See page 21.
- 7 Recommend the Main Sail and Sail Pack be laundered to remove mold. Sail pack zippers in need of restitching.

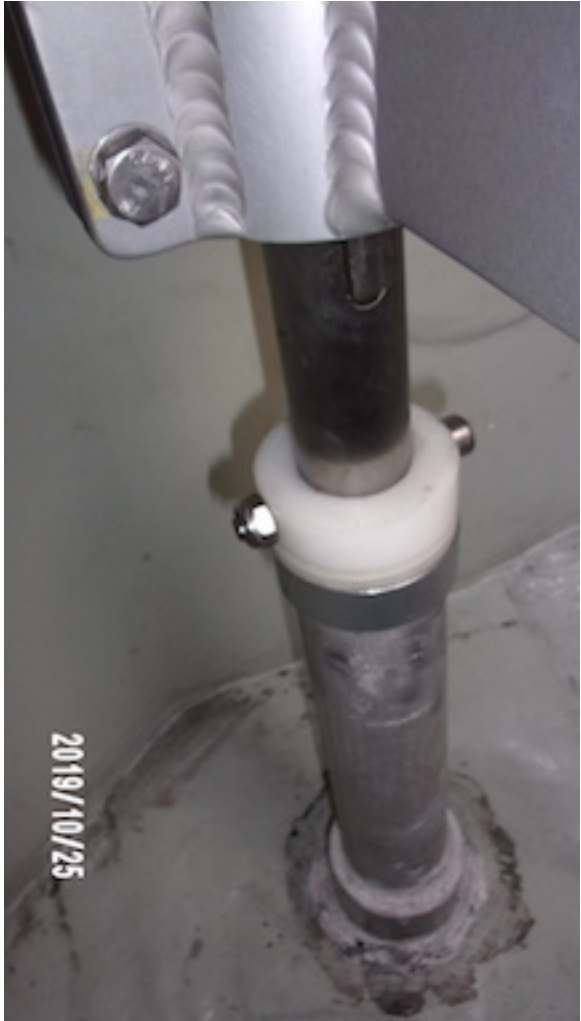
Found both rudders had approximately 1/2" side x side play and 1/4" to 3/8" fore and aft play. Rudder shafts are supported at the hull by aluminum tubes and at the top end by bearings installed on the under side of deck. Seal provided by aluminum tube which rises above the waterline. Welded Aluminum arm keyed to shaft, fasteners appear tight.

(Left) Rudder Shaft Tube & Hull Support

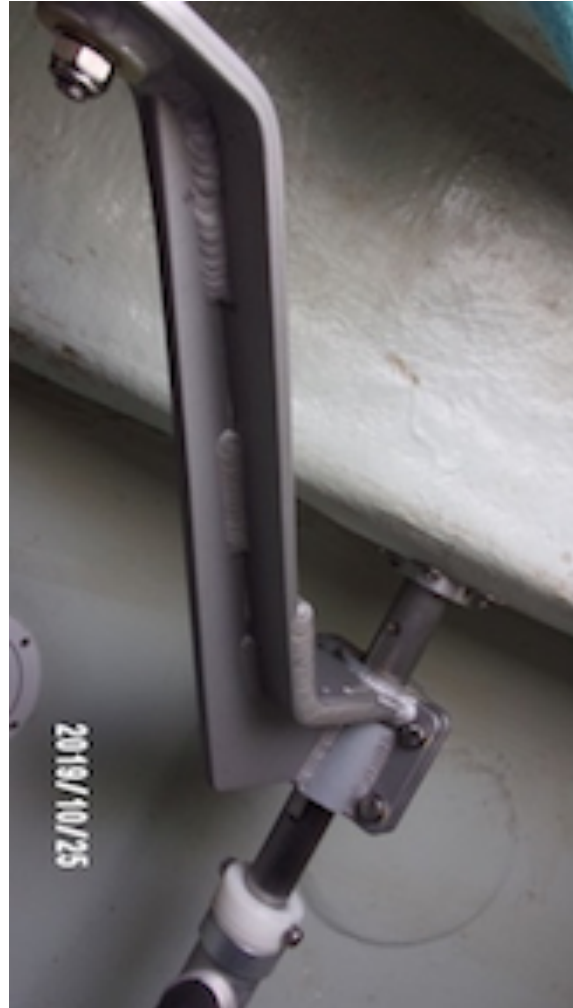
(Right) Upper end of shaft & bearing with tiller arm assembly.

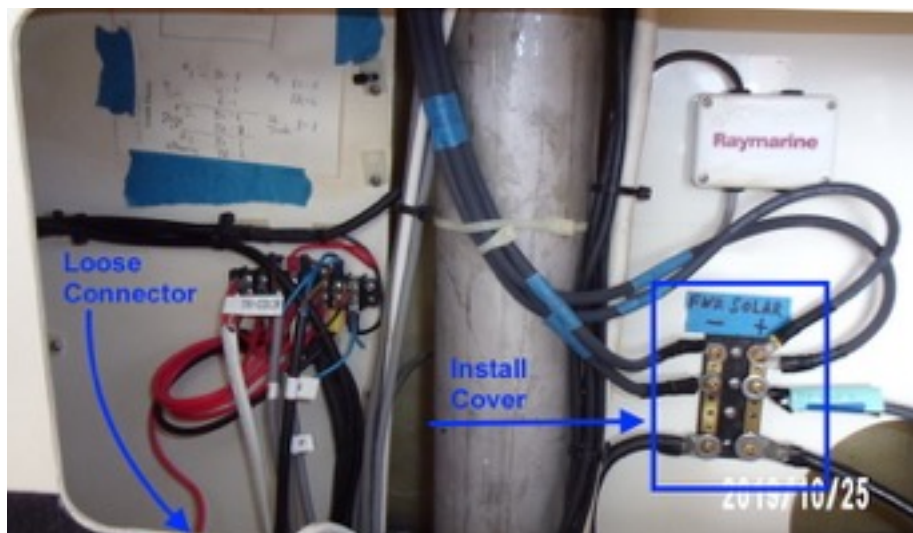
Mast Wires: Accessed In Salon. Secure loose wire, Install cover over solar power buss.
No "Lightning Down Conductor Observed".
