Catamaran Survey Report

Mitch Witt Marine Surveyor

44' Leopard Catamaran 2014

Survey Objective : Condition & Value pending purchase.

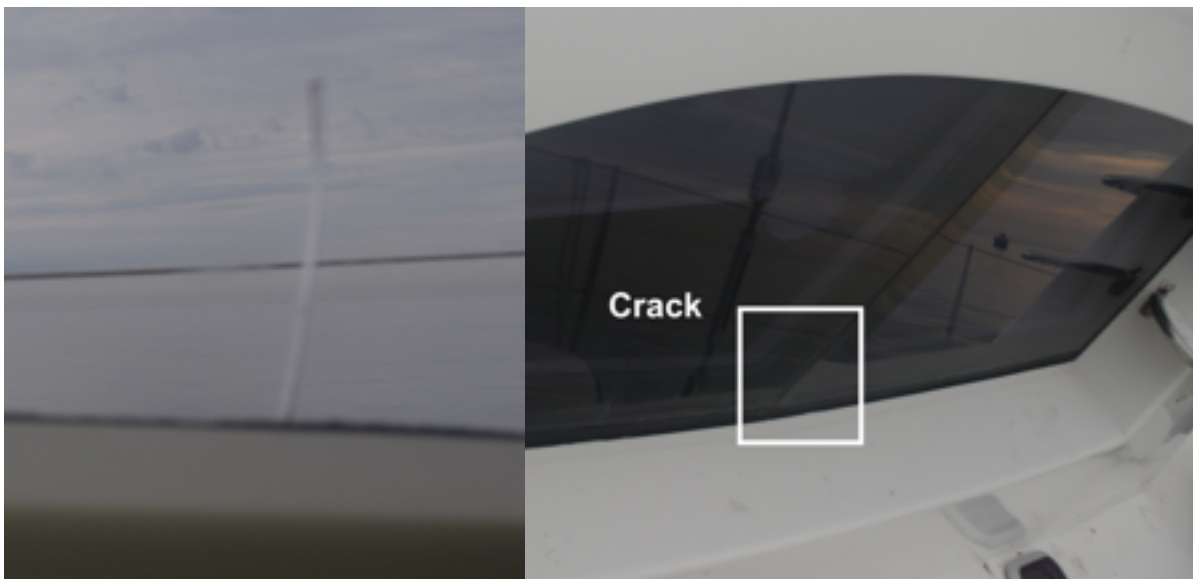
Decks: `	Cored decks with original gel coat undamaged, no chips or cracks observed. No indication of delamination or soft spots, decks, including non-skid surfaces in above average cond.
Handholds	Hand rails along cabin top and cockpit top, P&S with hand holds at steps up to cabin top. Hand rails also at stepped transoms. See Photos, Page 22/23.
Hatches & Gaskets	Deck hatch lenses in good condition, no cracks or crazing observed. Salon and cabin windows also in good condition with the exception of a 4 to 5" crack at the bottom of the port side forward salon window. No evidence of previous leaks observed.

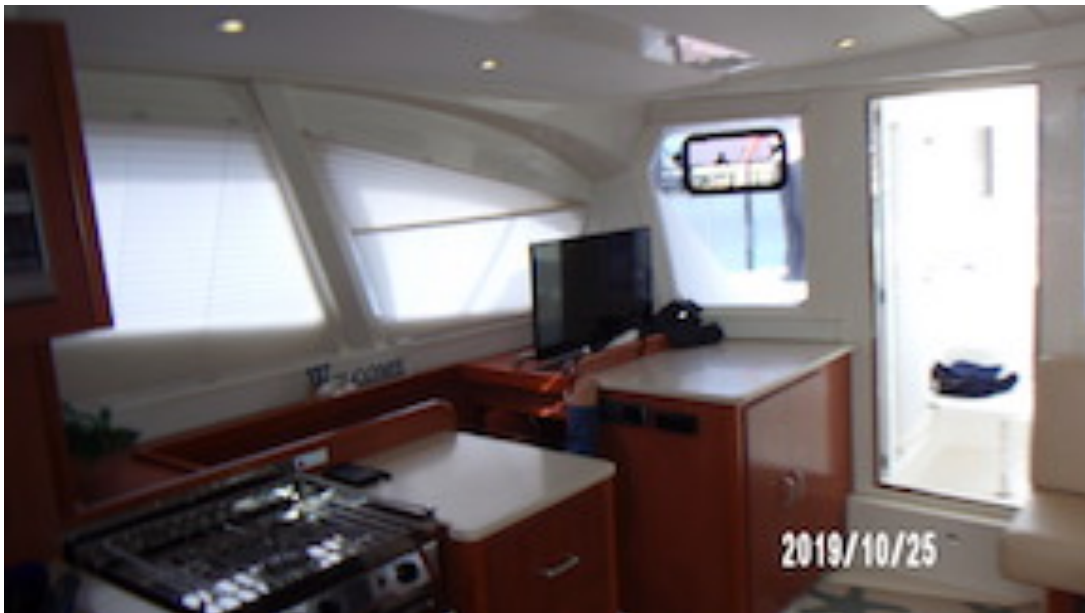
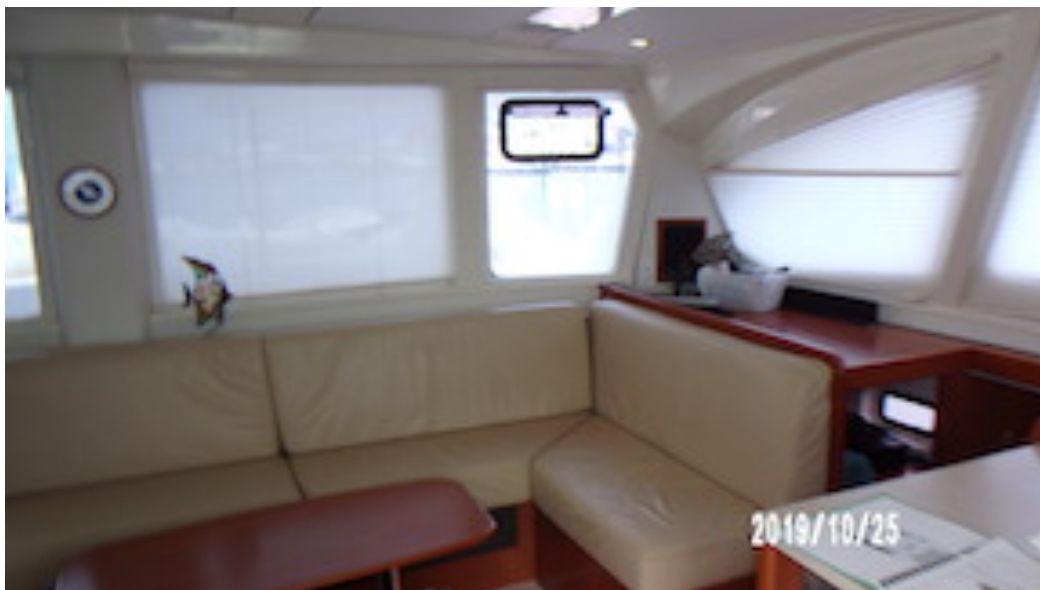
Entering salon from aft cockpit, Galley is to Port, Settee and cocktail table to starboard.

Note Companionway Exit To Forward Cockpit (Right Side Photo)

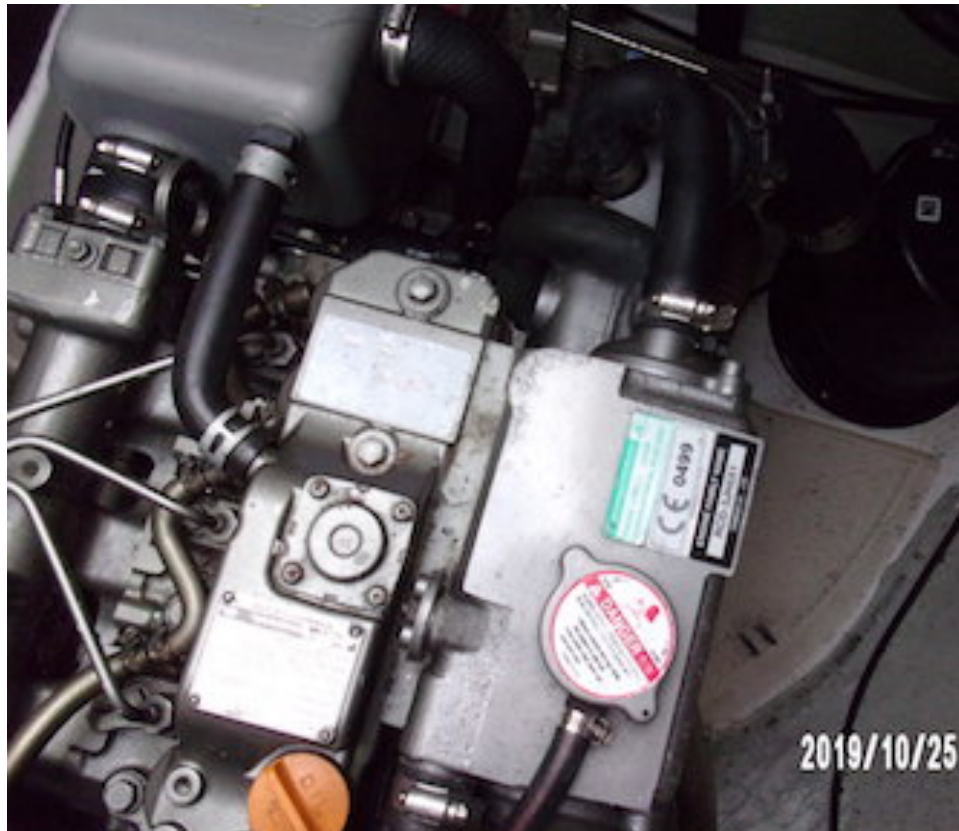
Engine compartment was clean, in above average condition.

Rubber *hull to sail drive seal* (within engine compartment) appeared in good condition.
